BABSON RESERVOIR DAM  
MA 00187

PHASE I INSPECTION REPORT  
NATIONAL DAM INSPECTION PROGRAM

DEPARTMENT OF THE ARMY  
NEW ENGLAND DIVISION, CORPS OF ENGINEERS  
WALTHAM, MASS. 02154

NOVEMBER 1978

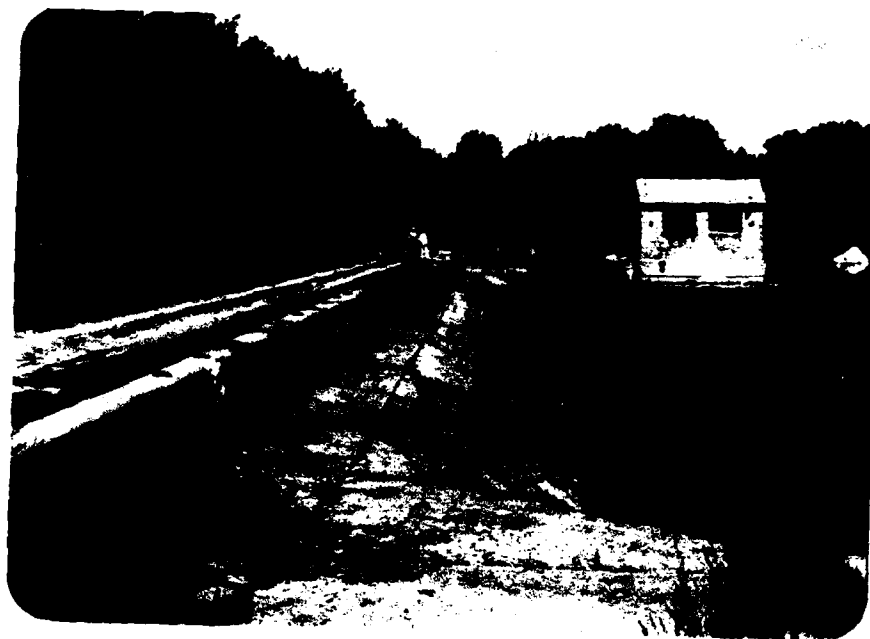
1. Overview of crest and upstream slope from left abutement.

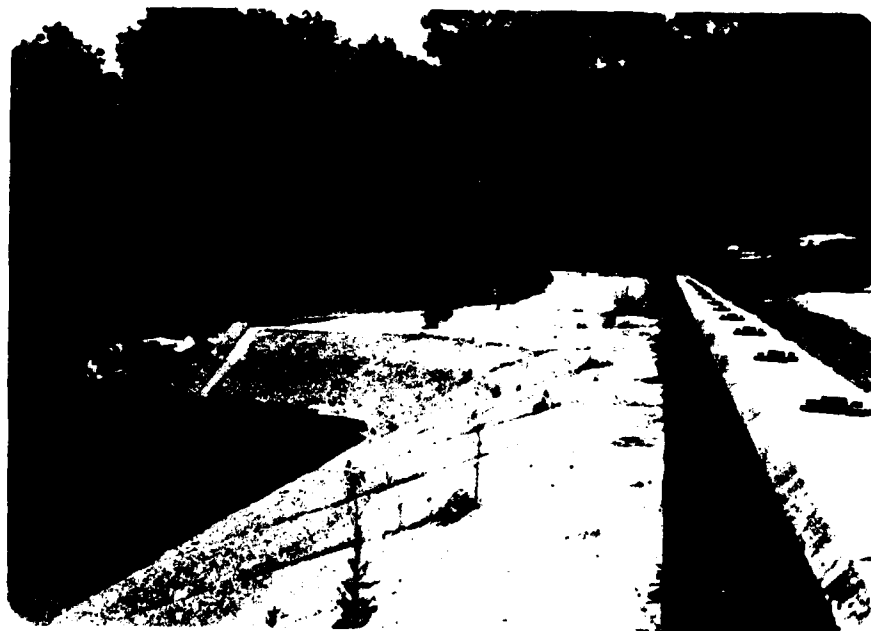
1. Concrete pavement slabs on the upstream slope have deteriorated in several localized areas, the most severe of which is shown in Photo No. 6. Isolated cracking and minor differential settlement of the slabs relative to the core wall has occurred. The sealant used at the slab joints has broken down and needs replacement. A number of joints now have vegetation. The upstream slope is shown in Photos No. 4 and 5.

4. Upstream paved slope at left end

7. Reseal all joints in the concrete pavement on the upstream slope, exposed core wall and spillway. Remove all loose concrete patches, fill all resultant voids, spalls, and missing pieces of pavement with concrete.

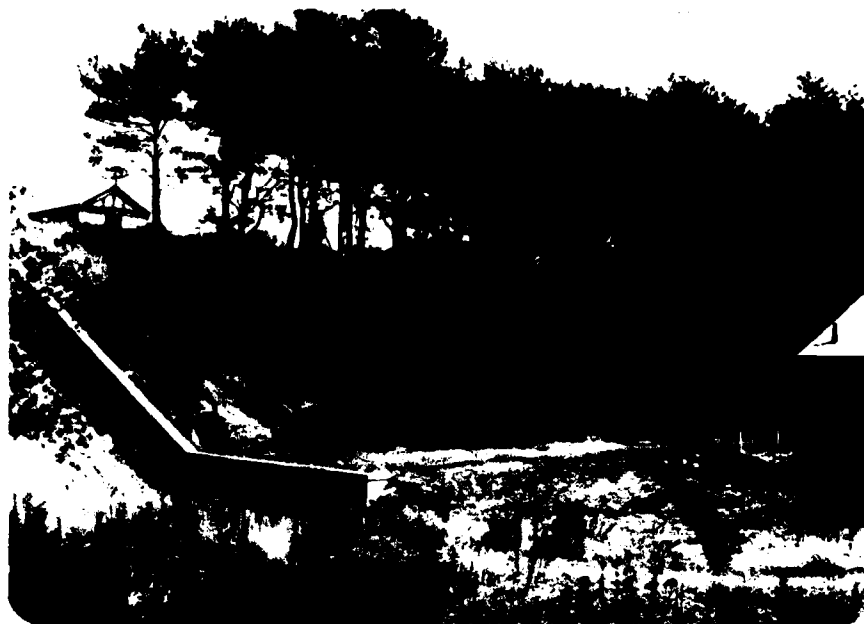
7. Downstream slope left of spillway

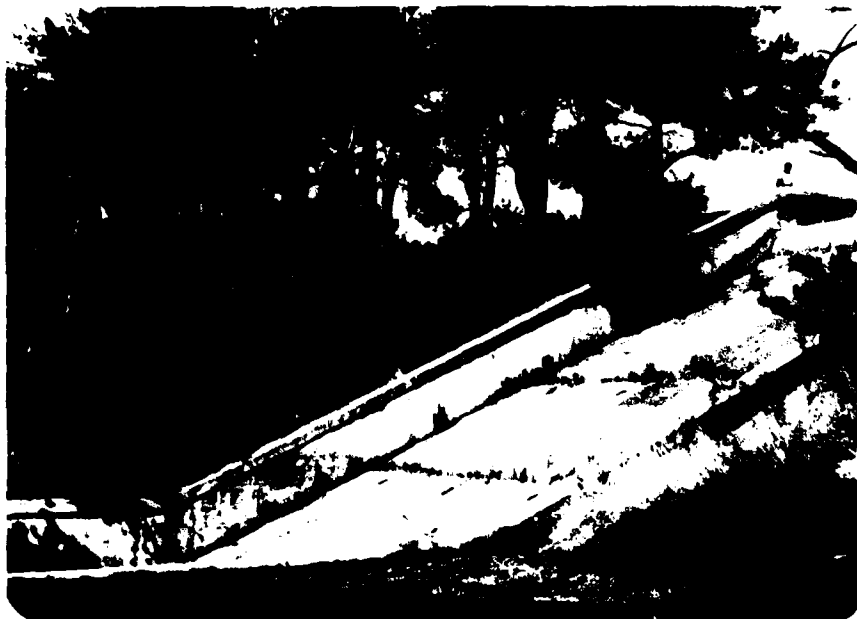
8. Downstream slope right of spillway

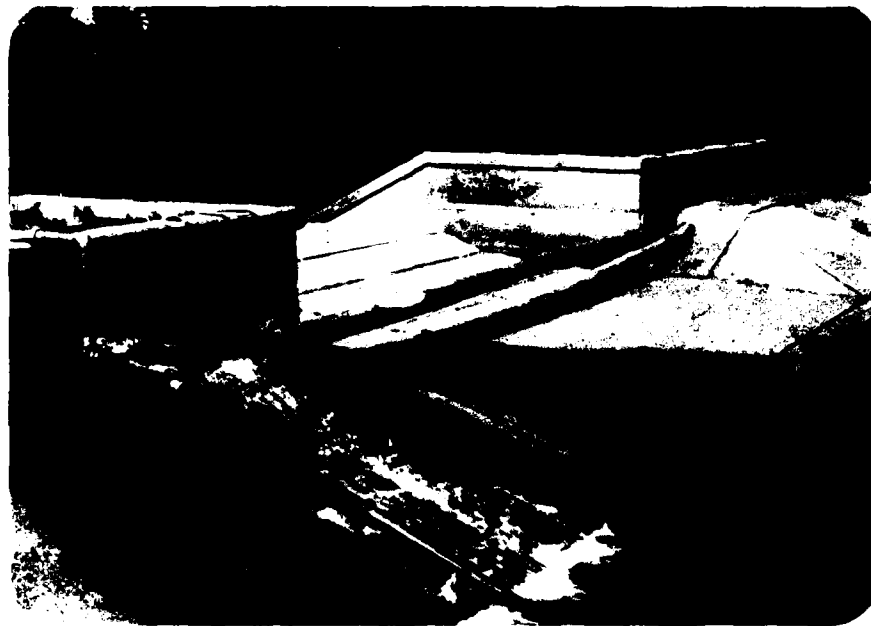
C. Appurtenant Structures. The spillway was found to be in good condition. The approach to the spillway is formed by pavement slabs on the upstream face of the dam, Photo No. 9. The surface of the slabs has eroded and the aggregate is exposed. The sealant at slab joints has broken down. Two logs are present at the entrance to the spillway, Photo No. 9. The impact of these logs against the core wall has caused spalling of the wall. Flashboards on top of the weir are in good condition. The flashboards have been securely bolted to each other and fastened to the training walls. It is questionable whether these flashboards would release under flood conditions.

9. Spillway approach and log boom

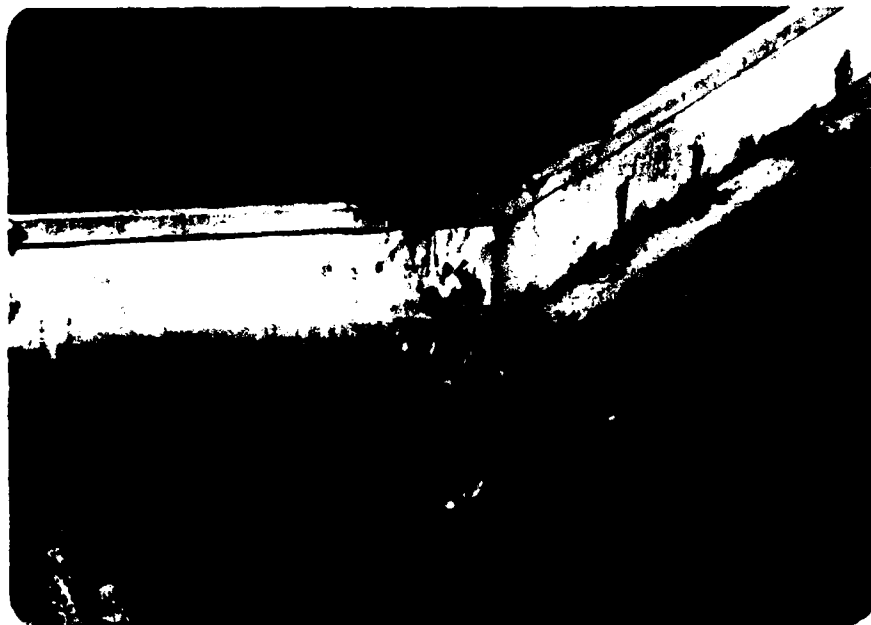
The side walls of the stilling basin are of reinforced concrete. The left side wall shows considerable cracking and efflorescence. This wall should be considered in good to fair condition. The right side wall shows minor cracking and some efflorescence. This wall is in good condition. The end walls of the stilling basin are of cut stone masonry. One small section of this wall, on the left side where it joins the downstream channel, is on the verge of collapse. The rest of the cut stone masonry wall is in good condition with some open joints.

12. Training wall right of stilling basin
